PROPOSED SOLAR PHOTOVOLTAIC FARM LAND AT BLACKBERRY LANE PEMBROKE

PRE APPLICATION CONDITION SURVEY

Technical Report 44111/1 July 2020 Mark Baker Consulting Limited

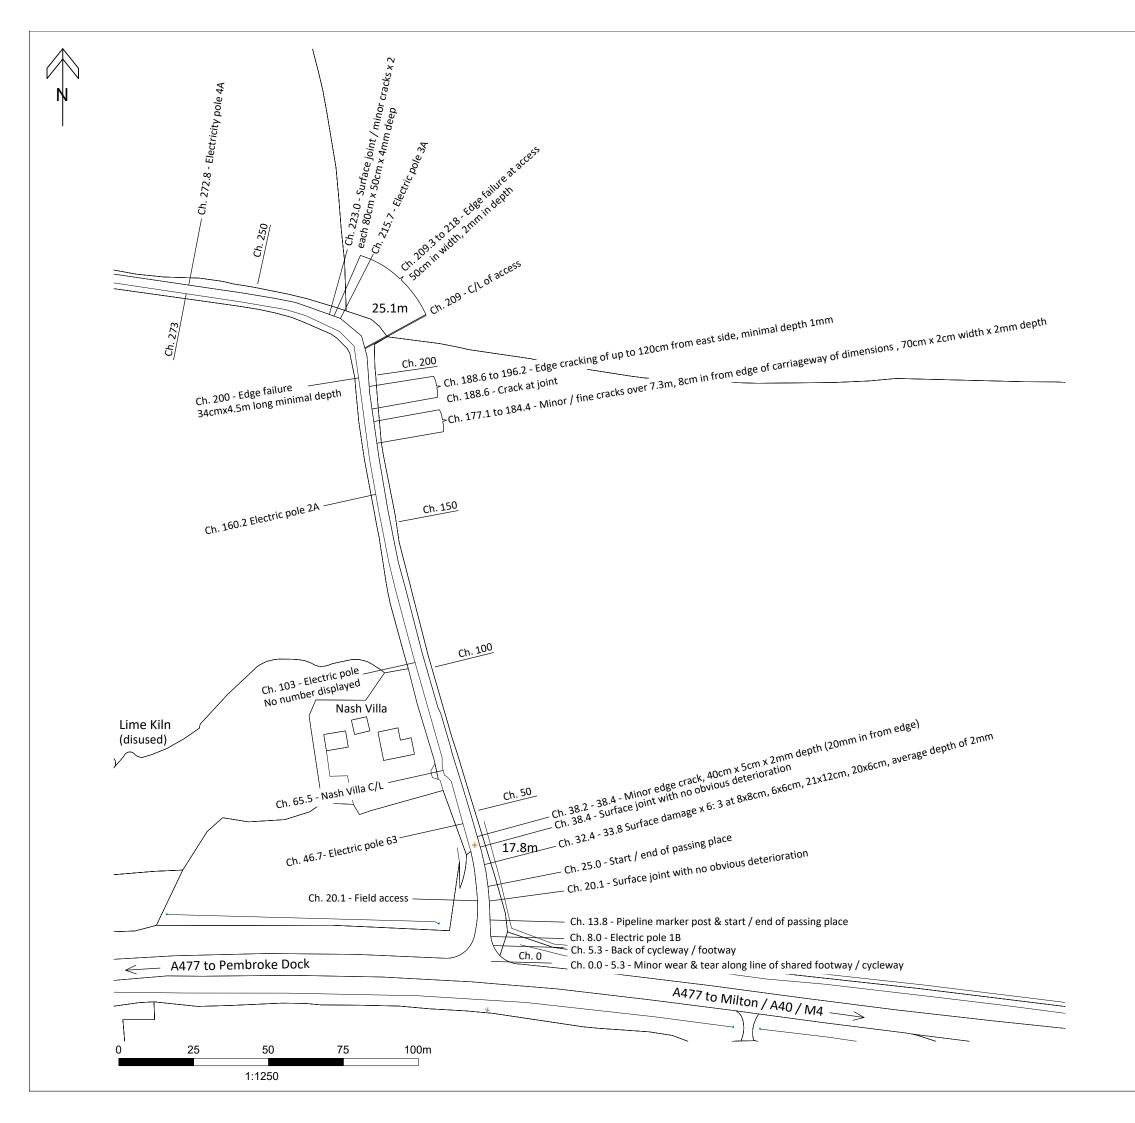
FIGURE

Chainage	Photograph	Feature
0m	n/a	Northern edge of carriageway / Give Way Line
0.0 to 5.3m	101	Minor wear and tear along the line of shared footway / cycleway

20.1m	102 / 103	Surface joint with no obvious deterioration
20.1m	n/a	Field access (West side)
25.0m	124	Start / end of passing place (East side)
32.4 to 33.8m	104	Surface damage x6 East side 8cm x 8cm, 6cm x 6cm, 21cm x 12cm, 20cm x 6cm all average depth 2mm

38.4 m	105	Surface joint with no obvious deterioration
38.2 to 38.4m	105 / 106 / 107	Minor edge crack East side 40cm x 5cm 2mm depth (2cm in from the carriageway edge)

177.1 to 184.4m	110 / 111 /112 /113	Minor / fine cracks over 7.3m typically 8cm in from carriageway edge over a total area of 70cm x 2cm with 2mm depth

188.6m	114	Crack at joint
188.6 to 196.2m	115 / 116	Edge cracking (East side) of up to 120cm from east side of carriageway minimal depth of 1mm
200.0m	117 / 118 / 119	Edge of carriageway failing 34cm x 4.5m long minimal depth (west side)

209.0m	120/121	Approximate centre line of proposed access
209.3 to 218.0m	121 / 122 / 123	Edge failure at access 50cm in width 2mm depth over 8.7m
215.7m	n/a	Electric pole 3A

223.0m	124	Surface joint / minor cracks x2 each 80cm x 50cm 4mm depth
272.8m	n/a	Electric pole 4A
