PROPOSED SOLAR PHOTOVOLTAIC FARM LAND AT BLACKBERRY LANE PEMBROKE

PRE APPLICATION CONDITION SURVEY

Technical Report 44111/1 July 2020 Mark Baker Consulting Limited

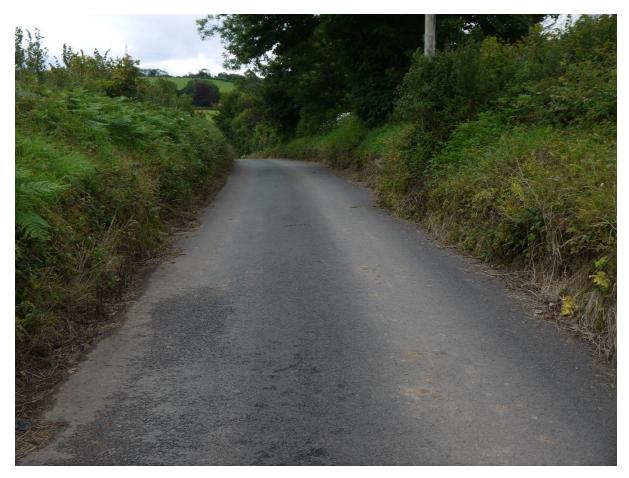
188.6m	114	Crack at joint
188.6 to 196.2m	115 / 116	Edge cracking (East side) of up to 120cm from east side of carriageway minimal depth of 1mm
200.0m	117 / 118 / 119	Edge of carriageway failing 34cm x 4.5m long minimal depth (west side)
